DEFENDANTS' EXPERT WITNESS DISCLOSURES

Donan Engineering was retained to conduct an inspection and create a written report of its findings regarding alleged hail and wind damage at Plaintiff J&S Welding, Inc.'s ("J&S Welding") property located at 2579 North 9th Avenue, Humboldt, Tennessee 38343 (the "Property").

OCTOBER 6, 2021

Burr Forman Claim No: 23930877
Envista Matter No: MAT-141908-G4Z7
REPORT DATE: January 6, 2023

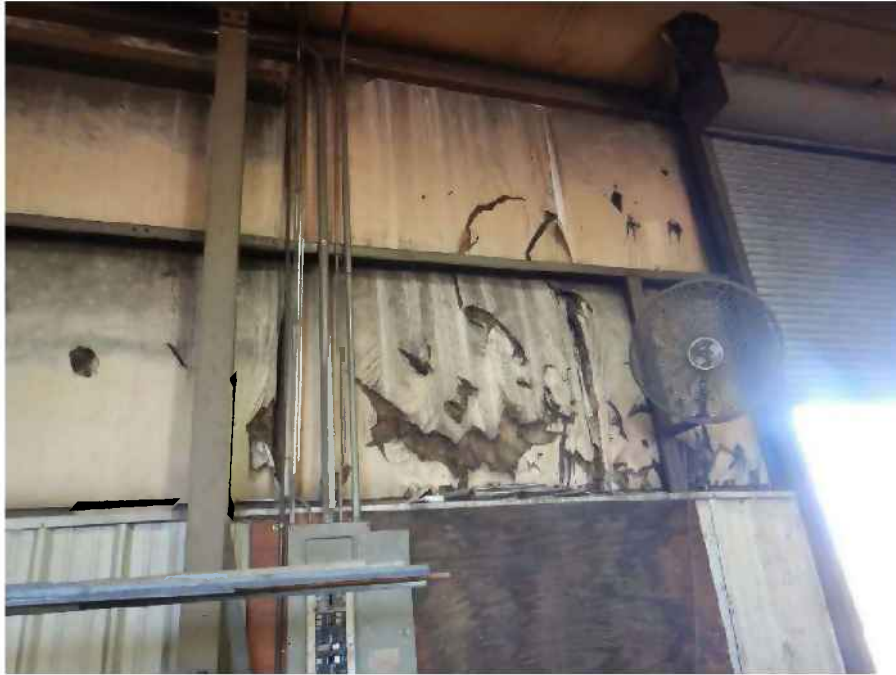
The west wall insulation is ripped and deteriorated above the interior west wall electric service panel in the main building (Photograph 5). The plywood that the panel is attached to is stained. Ripped and deteriorated insulation is below a north wall mounted exhaust fan (Photograph 6). A bucket is positioned at the top of the mezzanine stairs (Photograph 7). The ceiling's insulation above the bucket is not torn or missing.

Photograph 5: Deteriorated insulation and stained wood at west side electric panel.

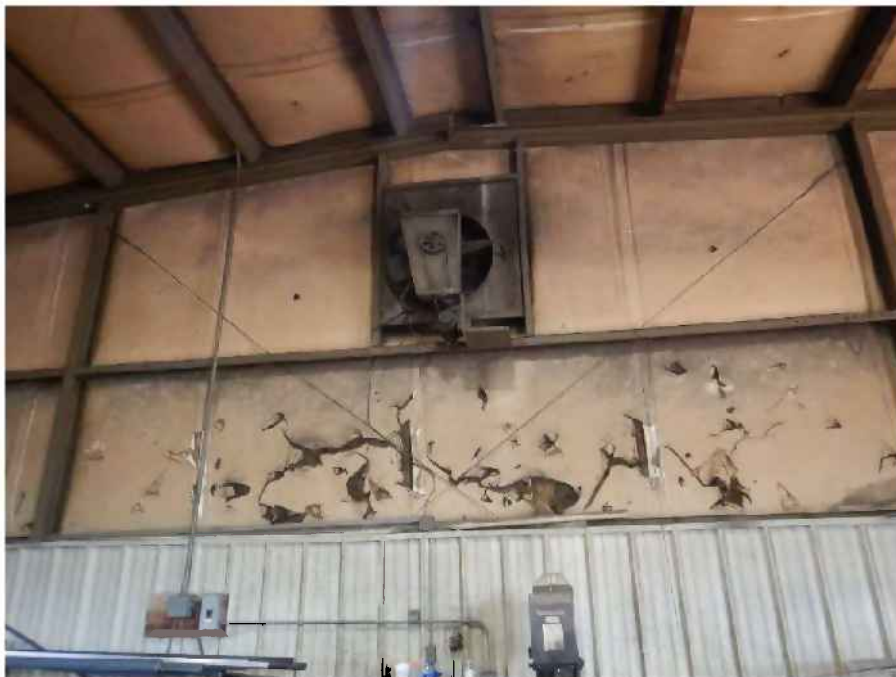
Photograph 6: Deteriorated insulation on north wall.

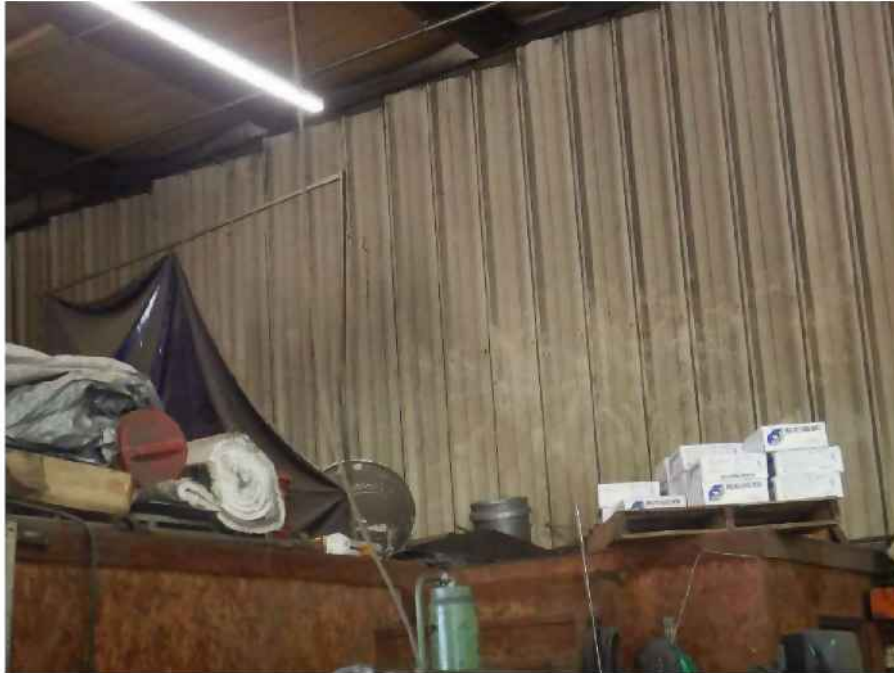
Photograph 7: Bucket on mezzanine at southeast corner of shop.

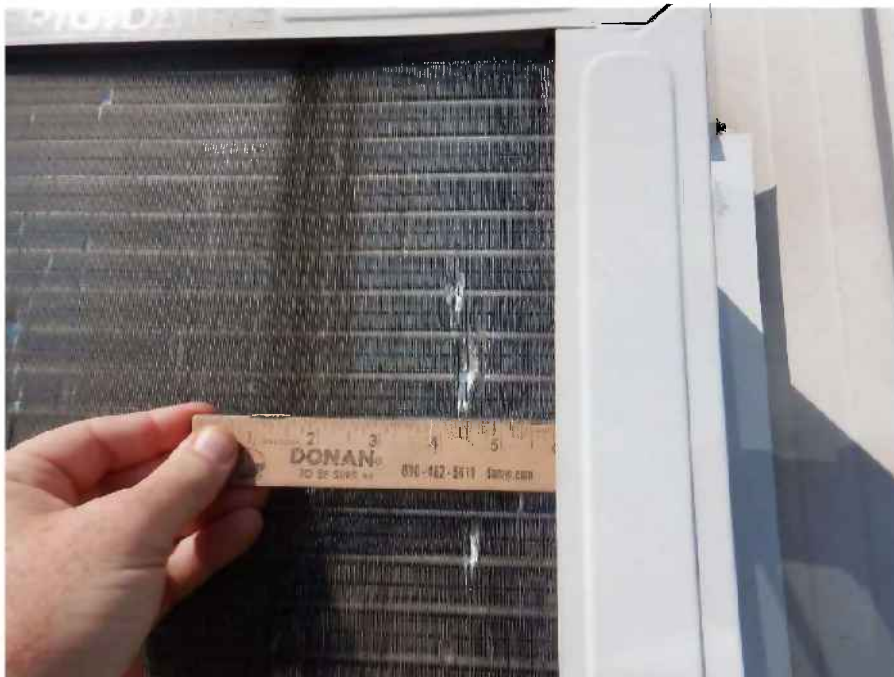
On the exterior of the main building dents about ½ inch wide are in the east side of an air conditioning window unit's fins (Photograph 8). A dent about ¾ inch wide is in the west siding of the main building (Photograph 9). Spatter marks between ¼ inch and ¾ inch wide are on the main building's north wall exhaust fan louvers and on the north side painted metal overhead door of the smaller building (Photographs 10 through 12).

Photograph 8: Dents in east side air conditioning fins.

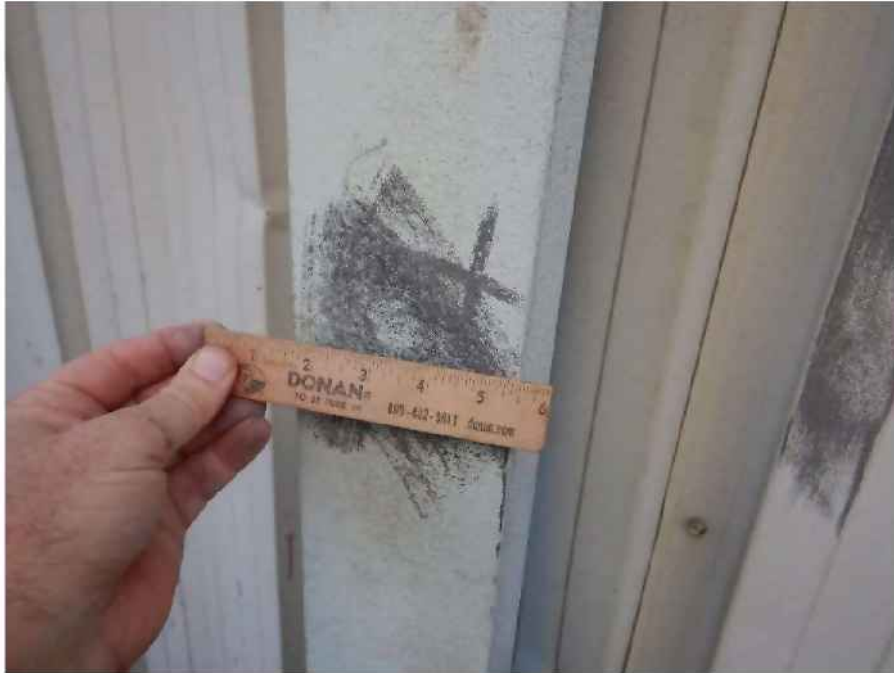
Photograph 9: Dent in west wall siding.

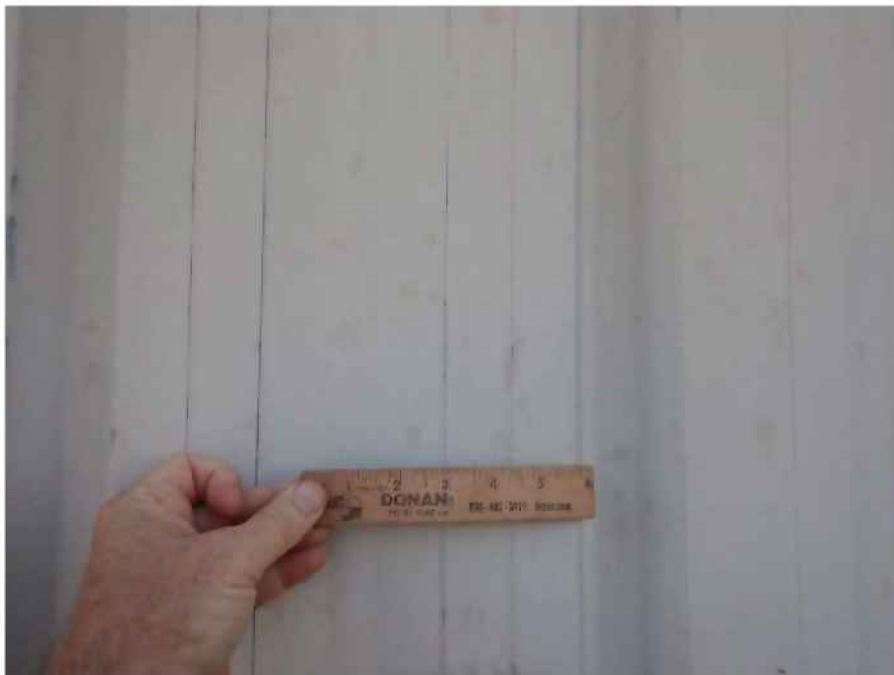
Photograph 10: Spatter on north wall.

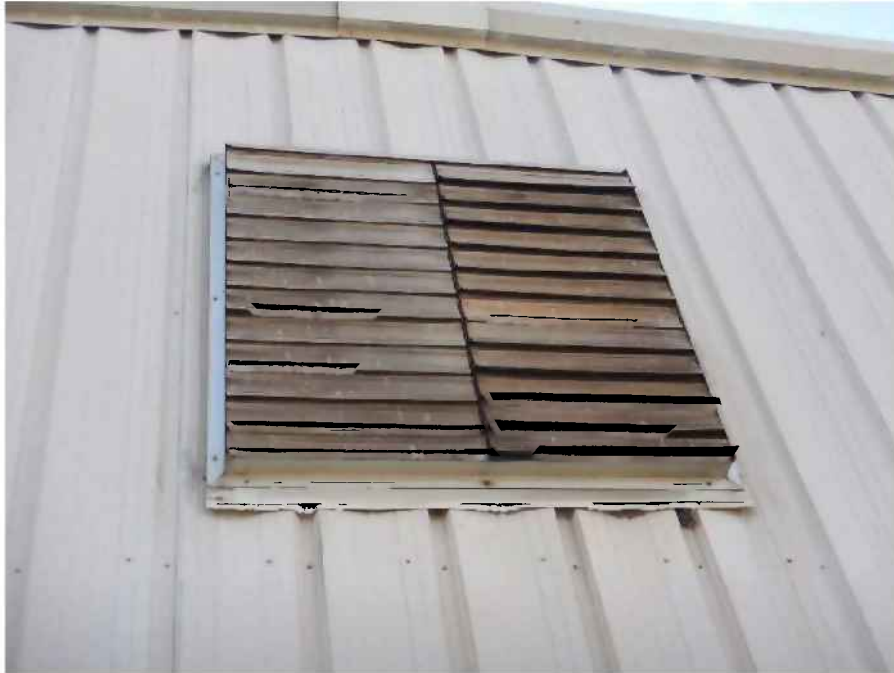
Photograph 11: Spatter on north wall louvers.

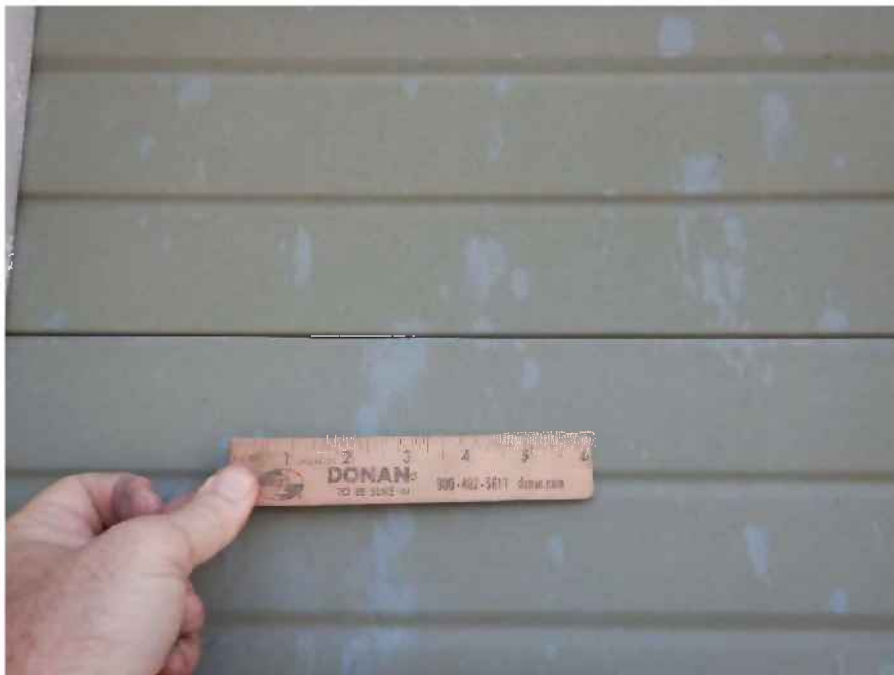
Photograph 12: Spatter on smaller building north side door.

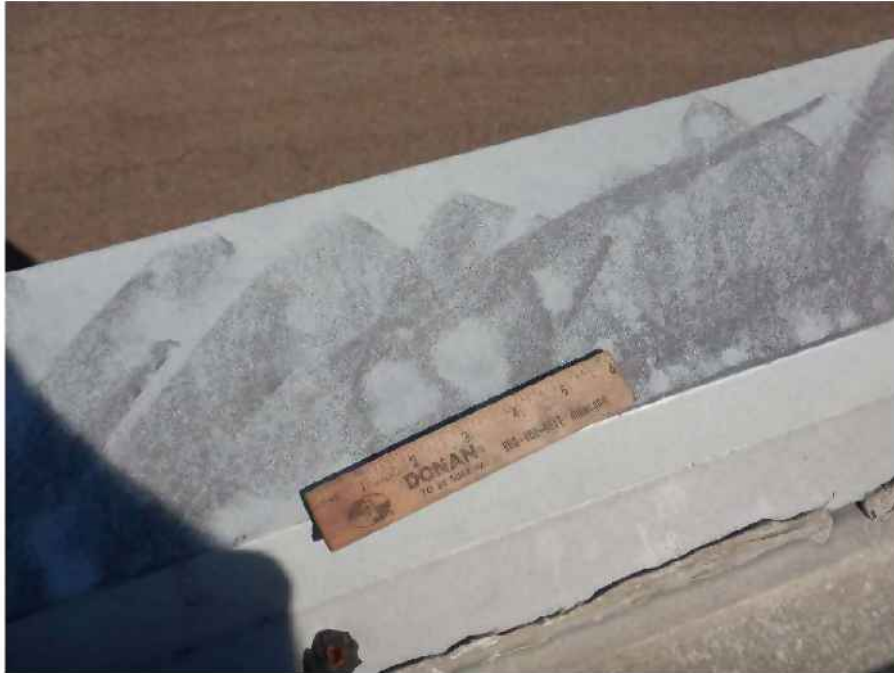
One-inch wide dents are in the trim metal along the north roof rake of the main building (Photograph 13). Dents approximately ¾ inch wide are in the metal panels of the roof (Photograph 14). Dents up to ½ inch wide are in the raised ribs of the roof (Photograph 15). No scratches or rusted surfaces accompany the indentations.

Photograph 13: Dents in north end roof trim metal.

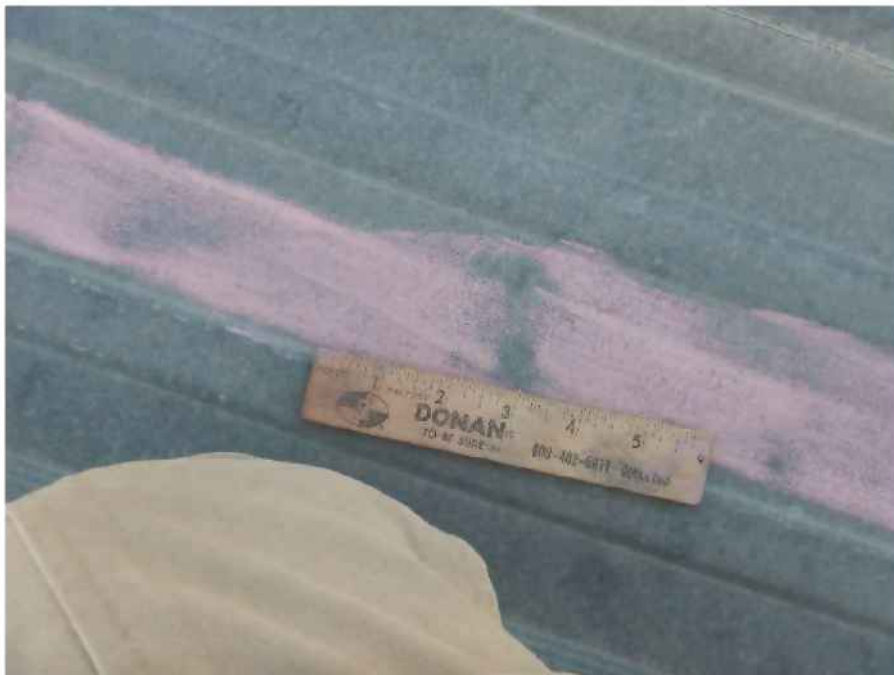
The roof covering is not scratched or rusted at the dent locations. The dents are due to hail strikes, but the damage is cosmetic in nature. The functionality of the roof has not been affected by the hail. Further, hail impacts would not result in the 3 foot to 5-foot long lifting of the overlap seams as is present on the main building. The lifted panels are the result of deferred maintenance. The leaks are due to missing screws and degraded sealant on the roof.

Photograph 14: Dents in roof covering.

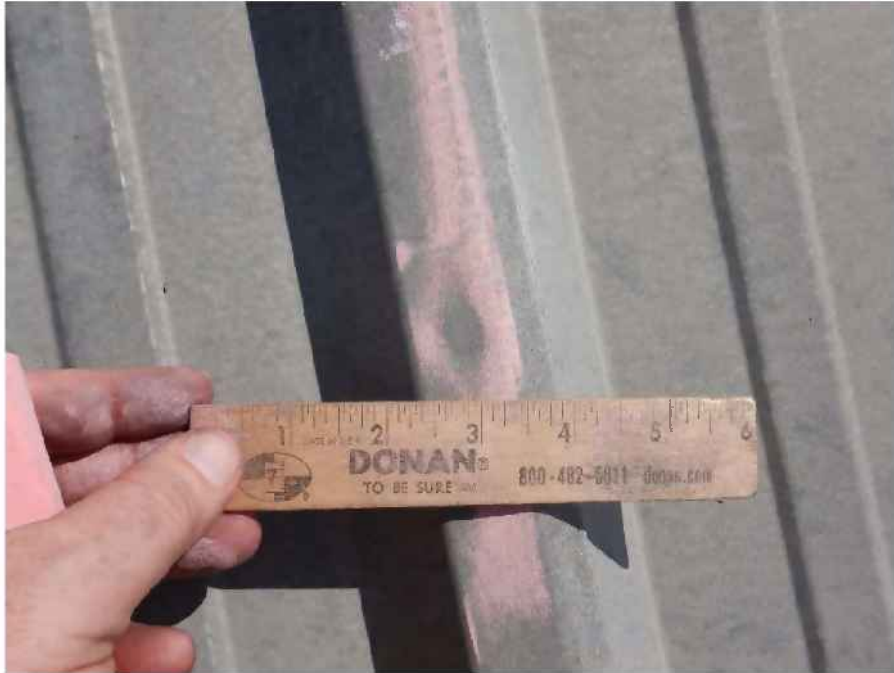
Photograph 15: Dent in rib metal.

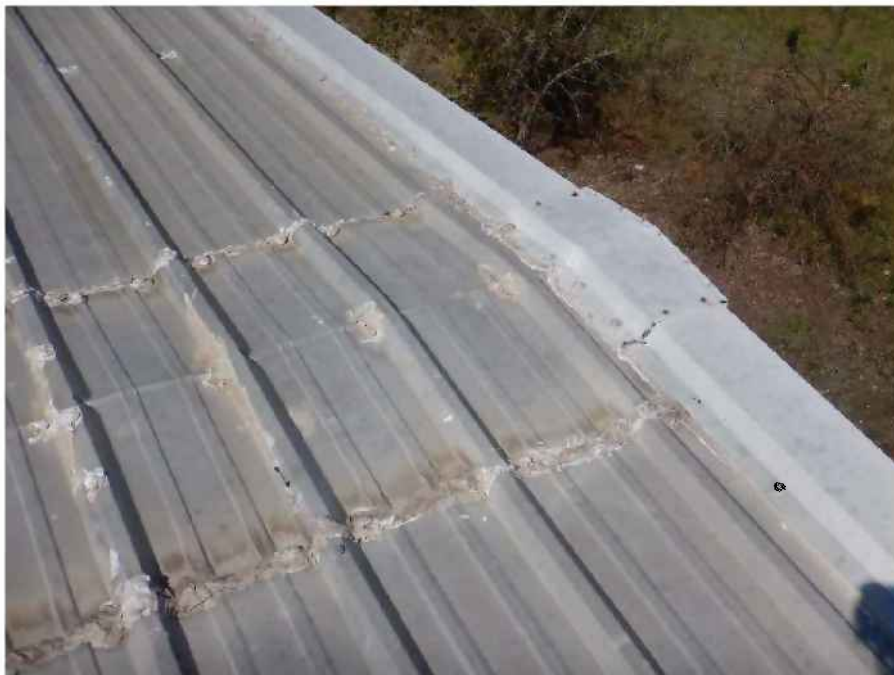
White and gray cracked sealant covers multiple seams at the north end of the main building's ridge (Photograph 16). A clear sealant is over multiple screw heads. Holes and cracks are in the sealant (Photograph 17). A raised screw is near the north rake near the ridge (Photograph 18). A missing screw head and a screw hole are along the west slope of this roof (Photograph 19).

Photograph 16: Sealant at north end of ridge.

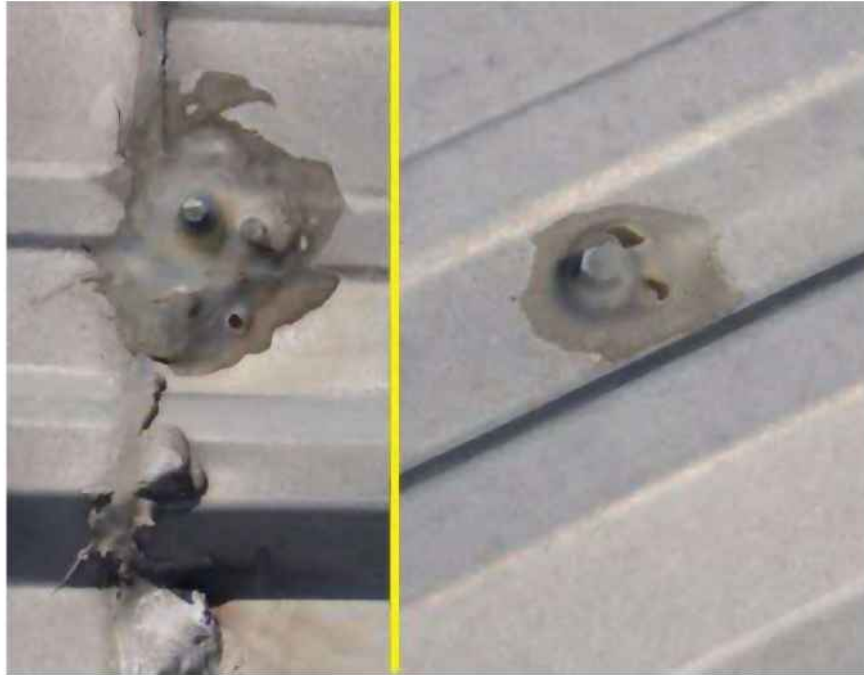
Photograph 17: Cracks and holes in sealant.

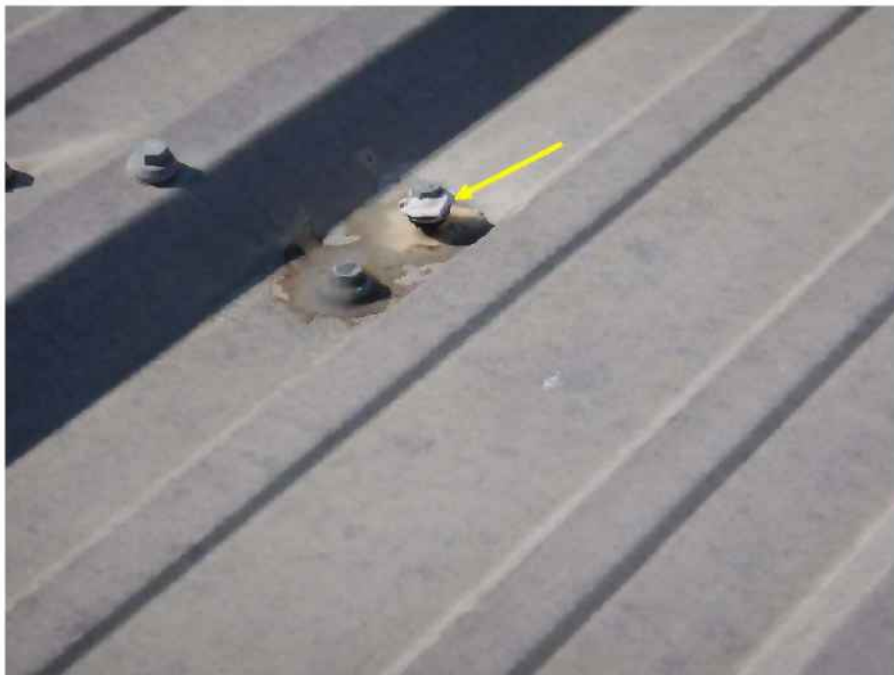
Photograph 18: Raised screw at north end of roof.

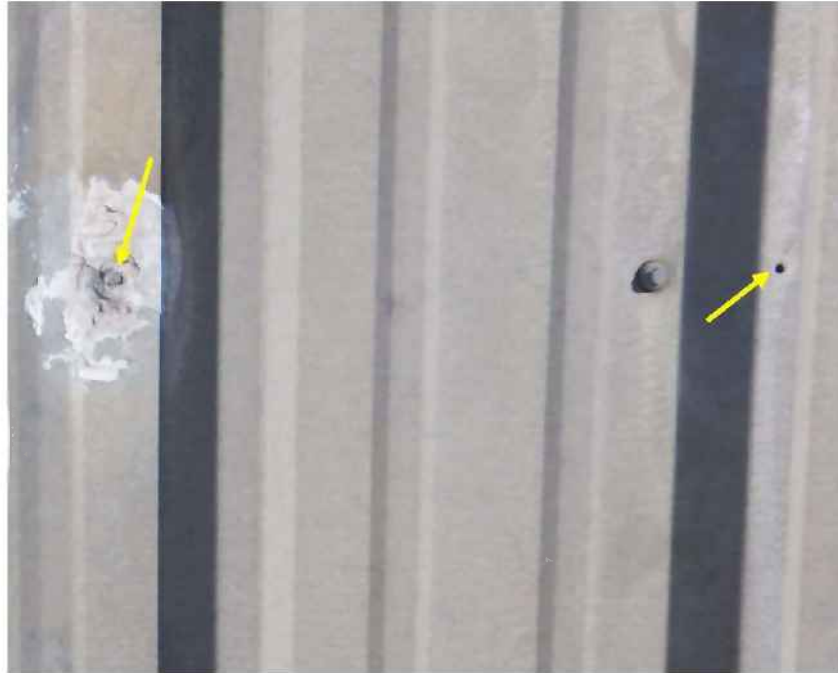
Photograph 19: Missing screw head and missing screw on west slope.

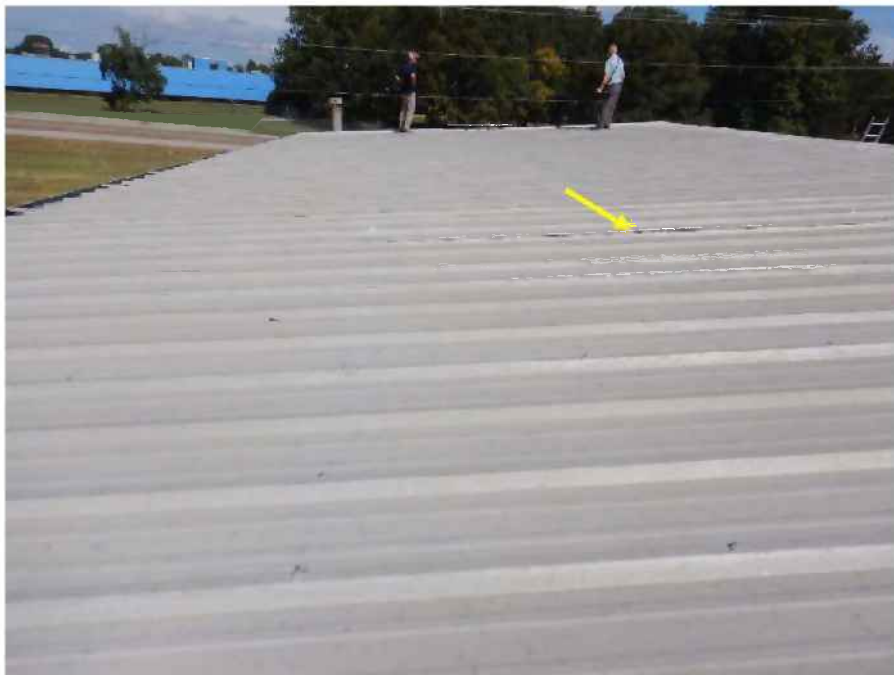
Photograph 20: Lifted lap on west slope.

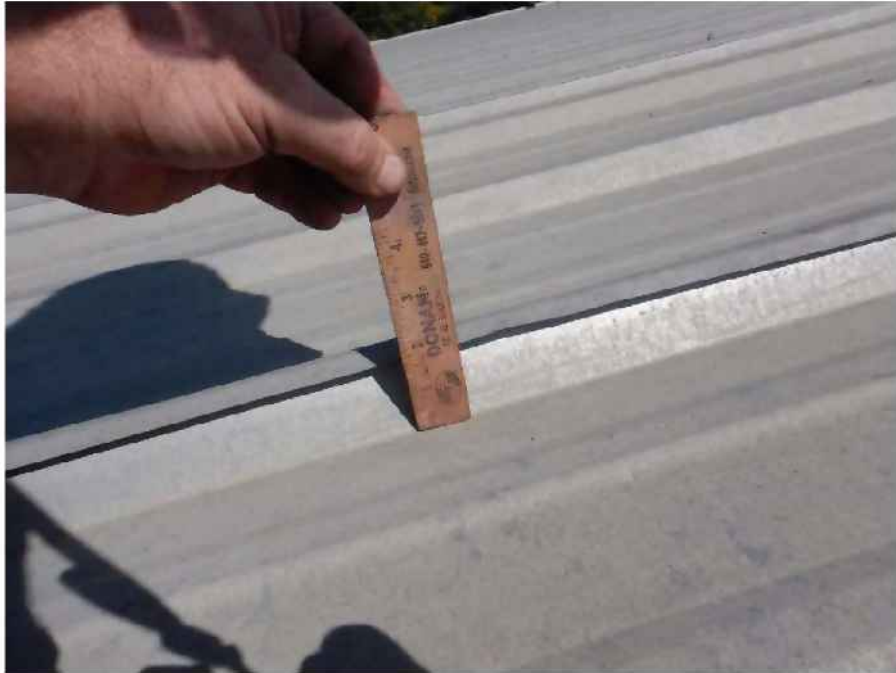
Photograph 21: Lifted lap on west slope.

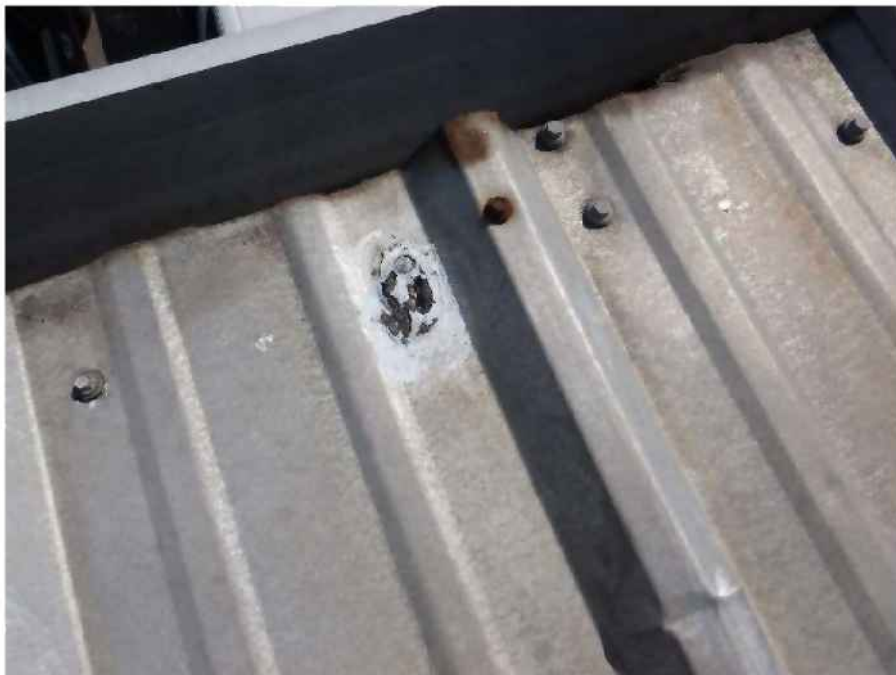
Several holes with missing sealant are near the eave of the main building's east slope (Photographs 22 and 23). Multiple bright, shiny metal screws are adjacent to gray and rusted screws near the east eave (Photograph 24).

Photograph 22: Hole near east eave.

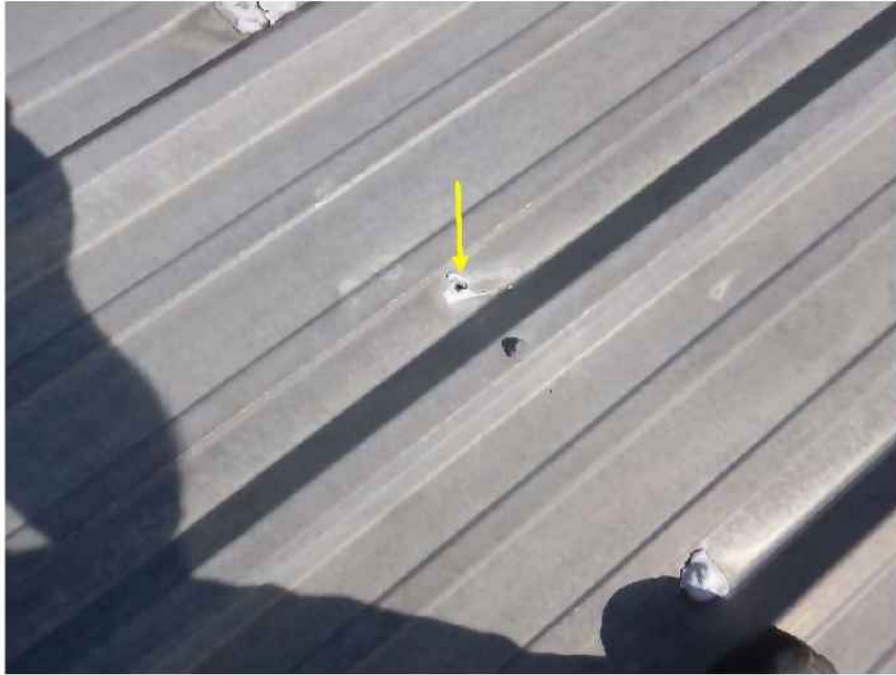
Photograph 23: Screw hole near east eave.

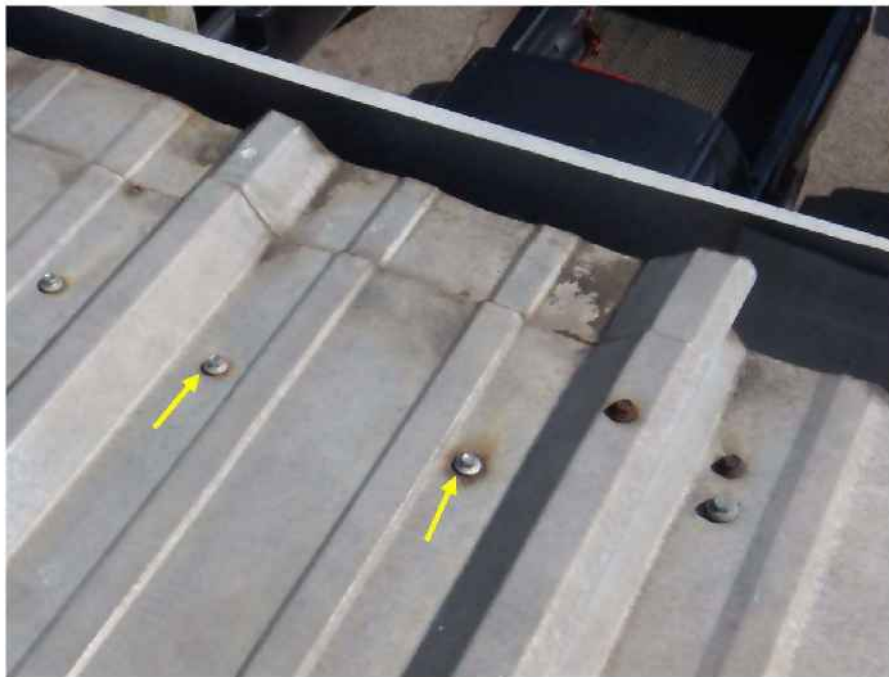
Photograph 24: Bright screw heads near east eave.

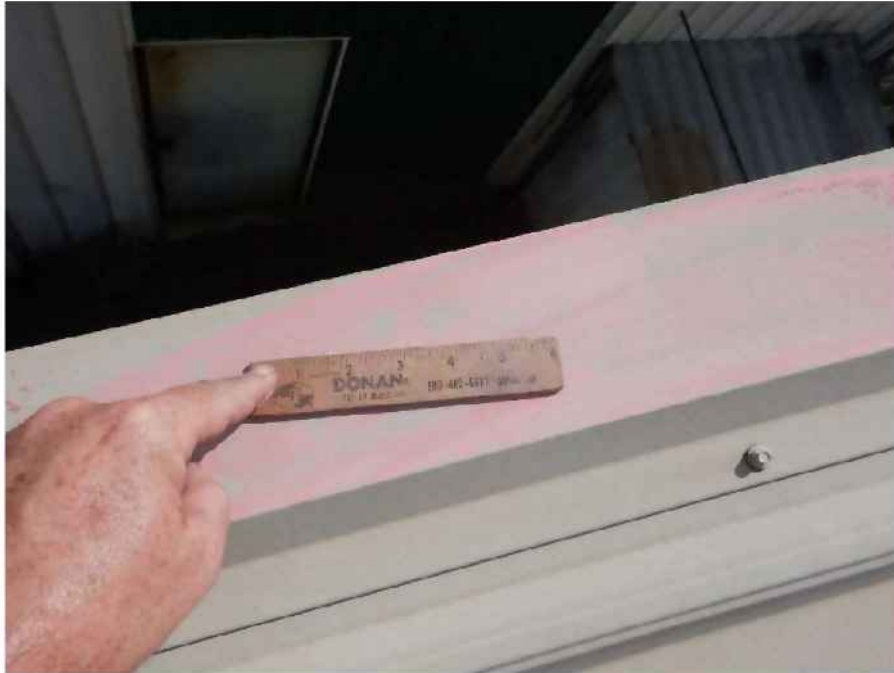
Dents approximately ½ inch wide are in the trim metal along the east rake of the small building (Photograph 25). Dents about ¾ inch wide are in the small buildings metal roof panels. No scratches or rusted areas are associated with these dents.

Photograph 25: Dents in east side trim metal of smaller building.

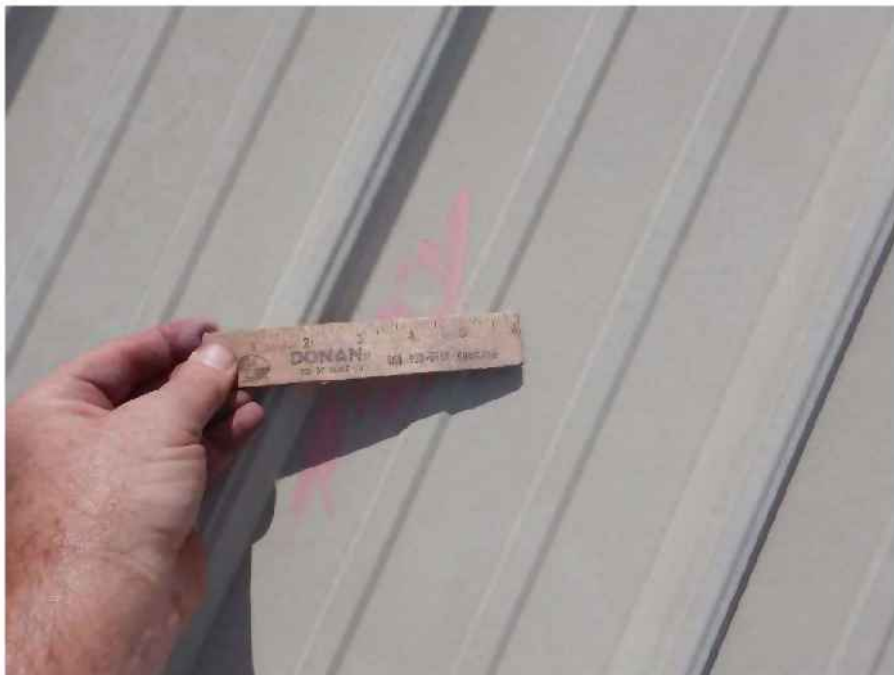
Photograph 26: Dent in north slope of smaller building roof.

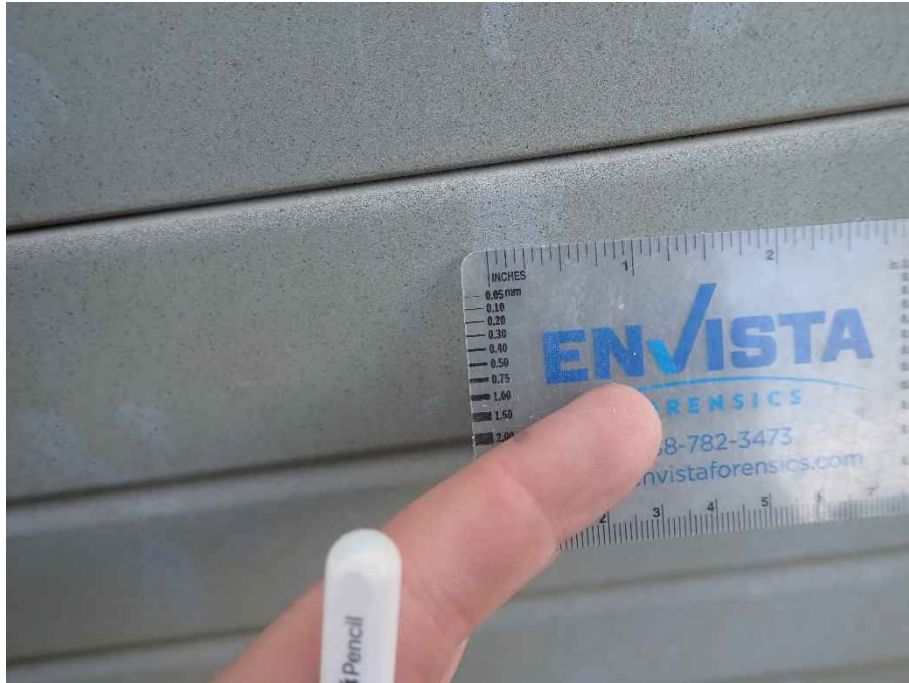
Photograph 3.

View of an overhead door with spatter marks for building #2.

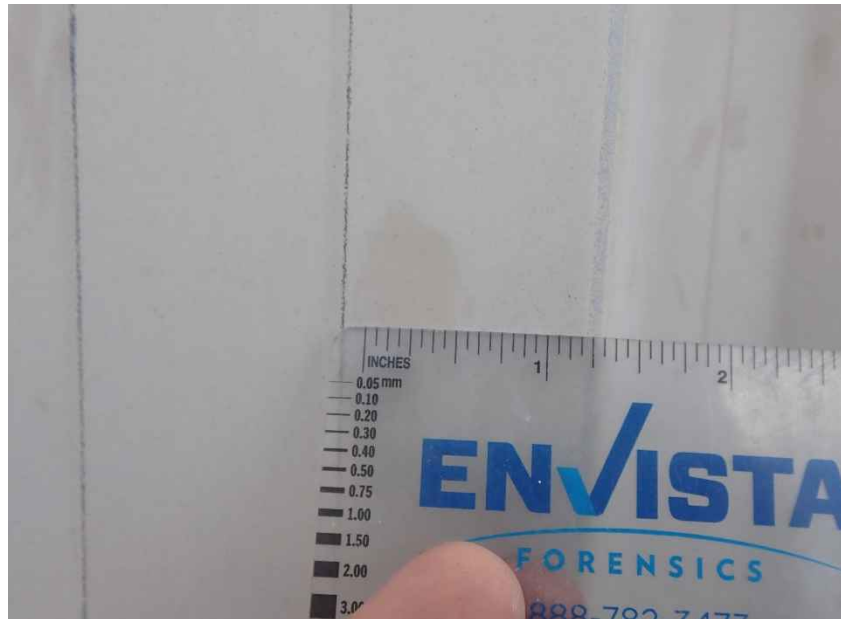
Photograph 5.

View of metal siding with spatter marks.

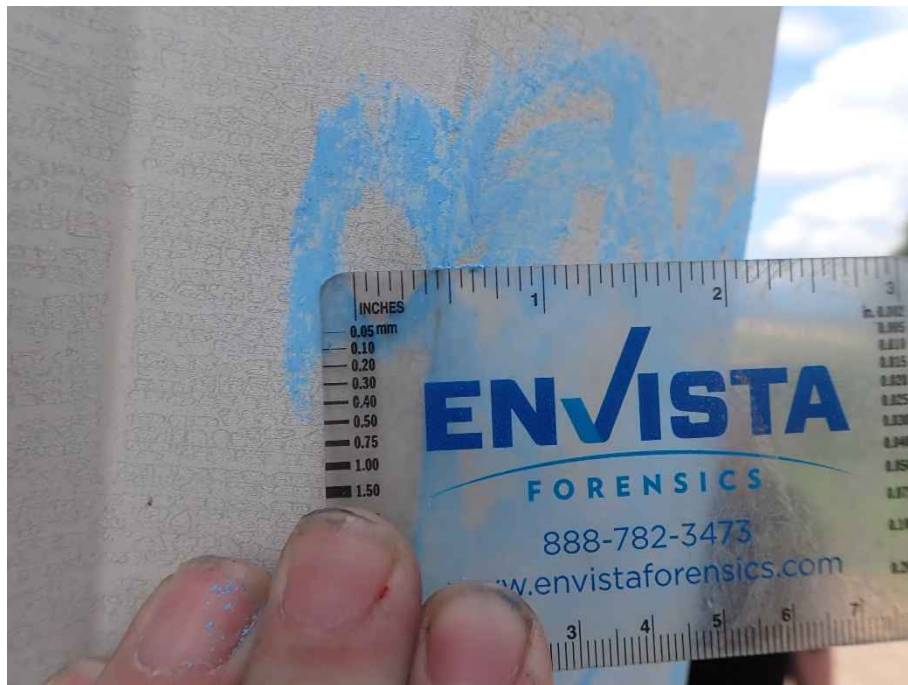
Photograph 6.

View of roughly circular indentations in metal siding.

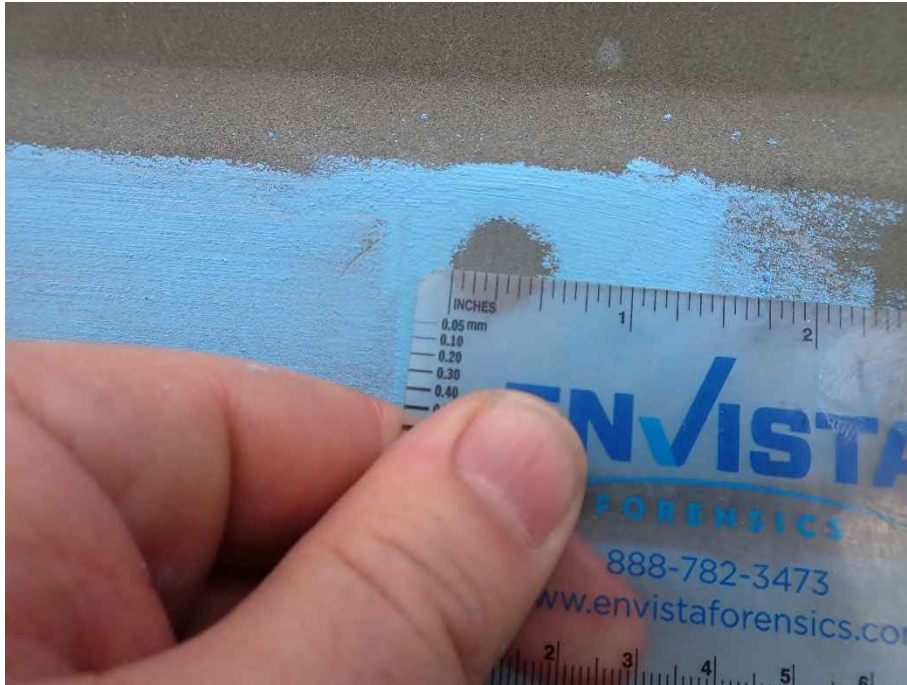
Photograph 7.

View of roughly circular indentations in metal siding.

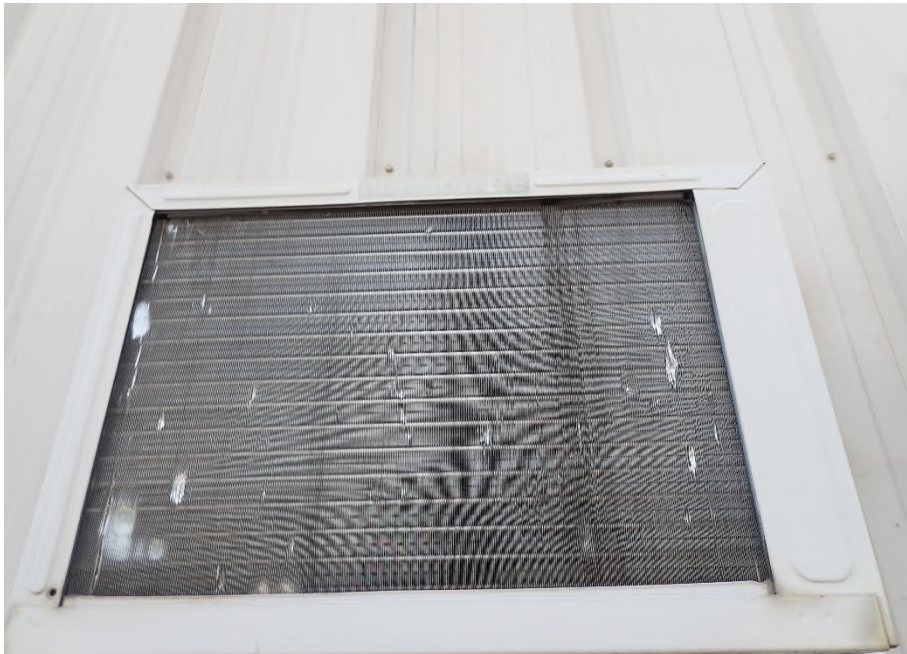
Photograph 8.

View of indentations in the condenser fins.

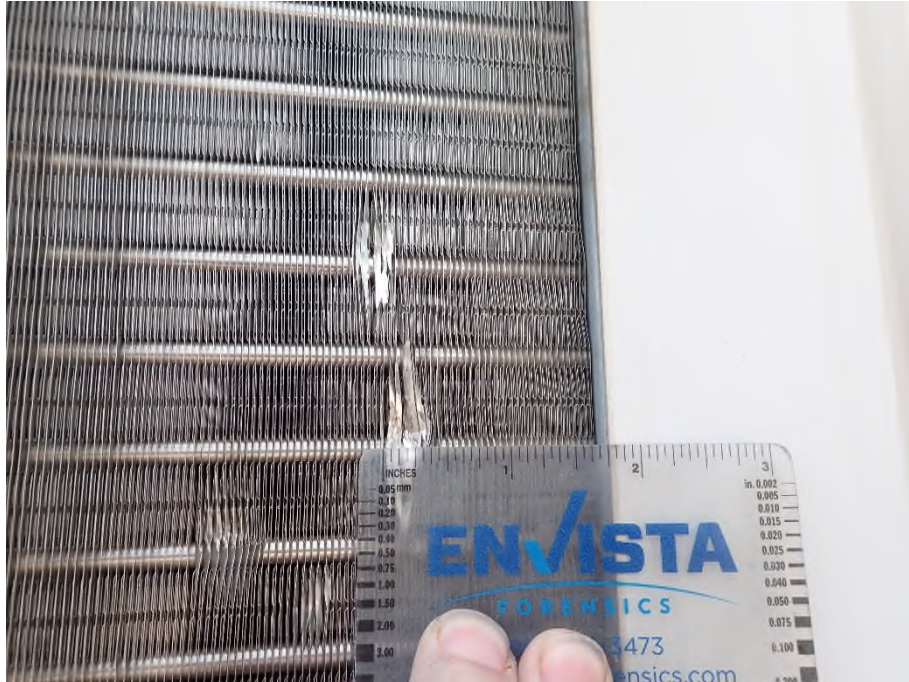
Photograph 9.

View of indentations in the condenser fins.

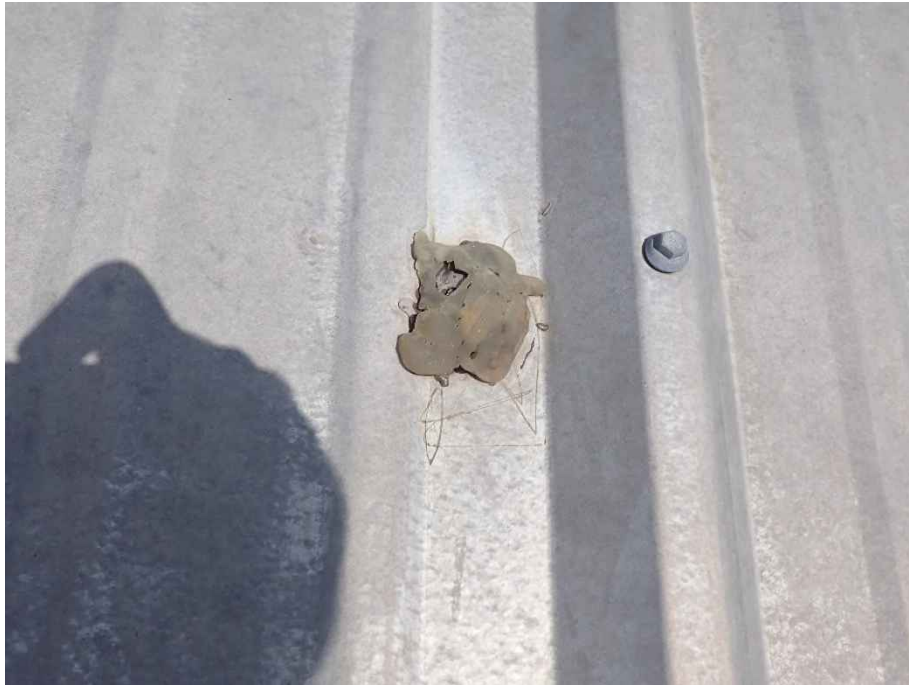
Photograph 11.

View of sealant material covering a fastener.

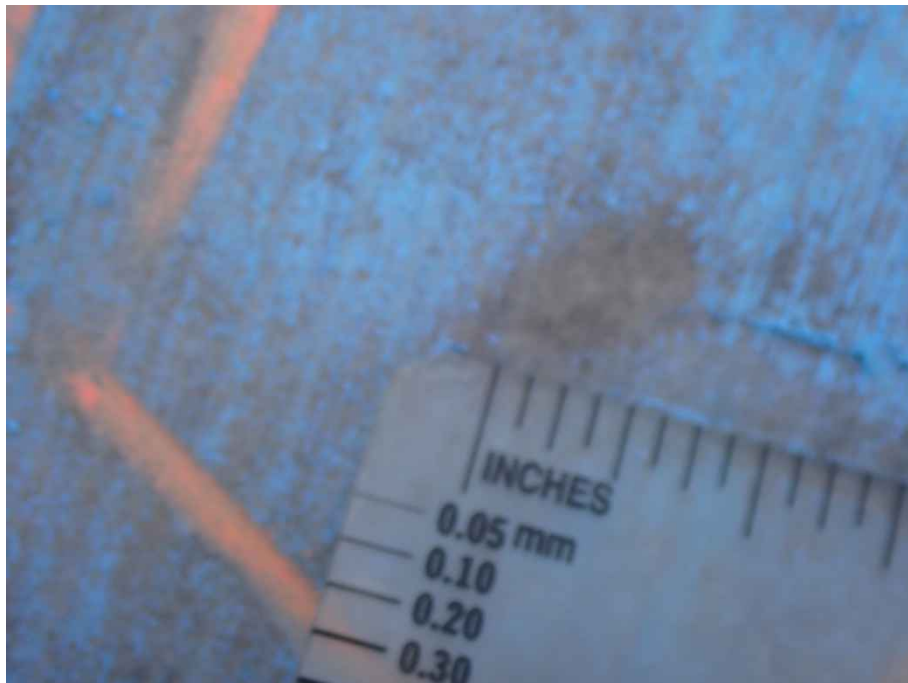
Photograph 12.

View of a roughly circular indentation in the roof covering.

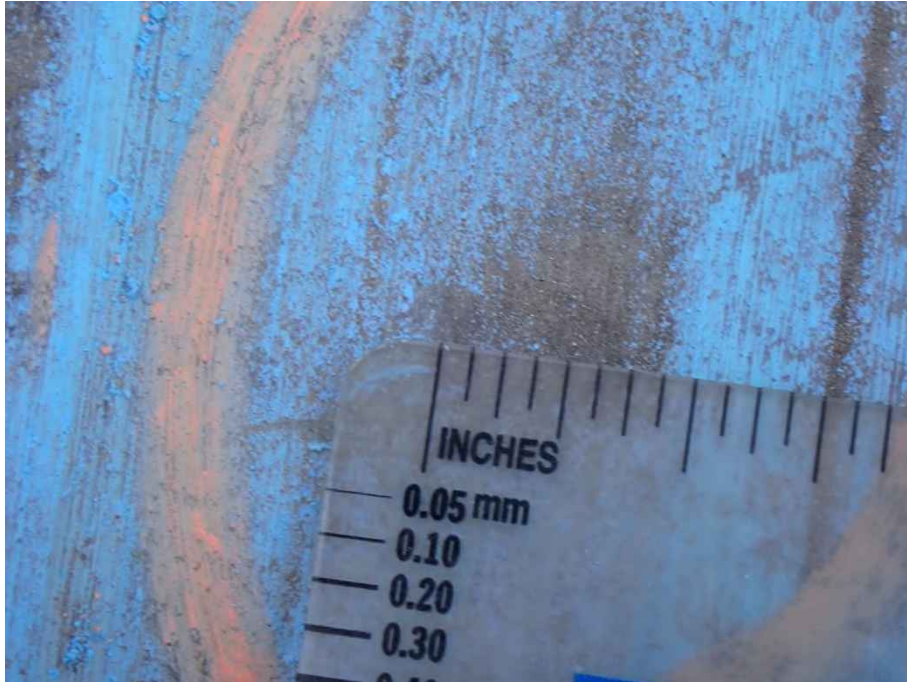
Photograph 13.

View of a roughly circular indentation in the roof covering.

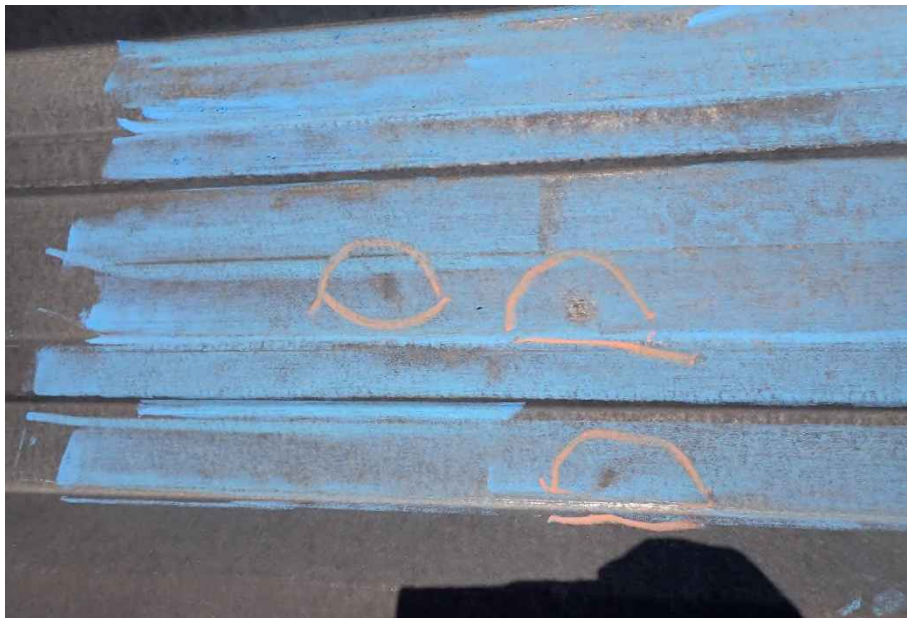
Photograph 14.

View of a roughly circular indentations in the roof covering.

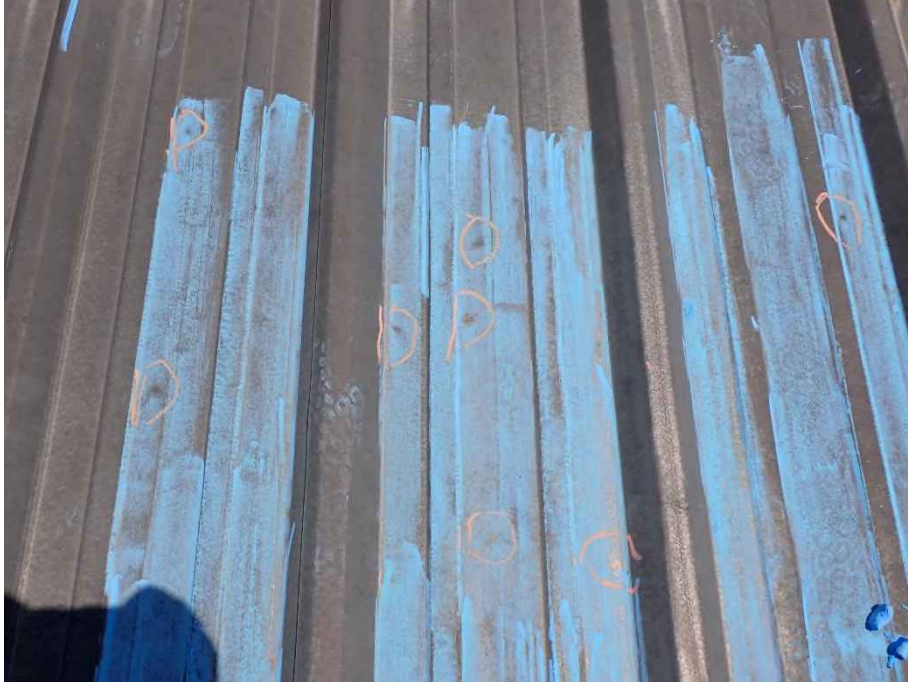
Photograph 15.

View of a roughly circular indentation in the roof covering.

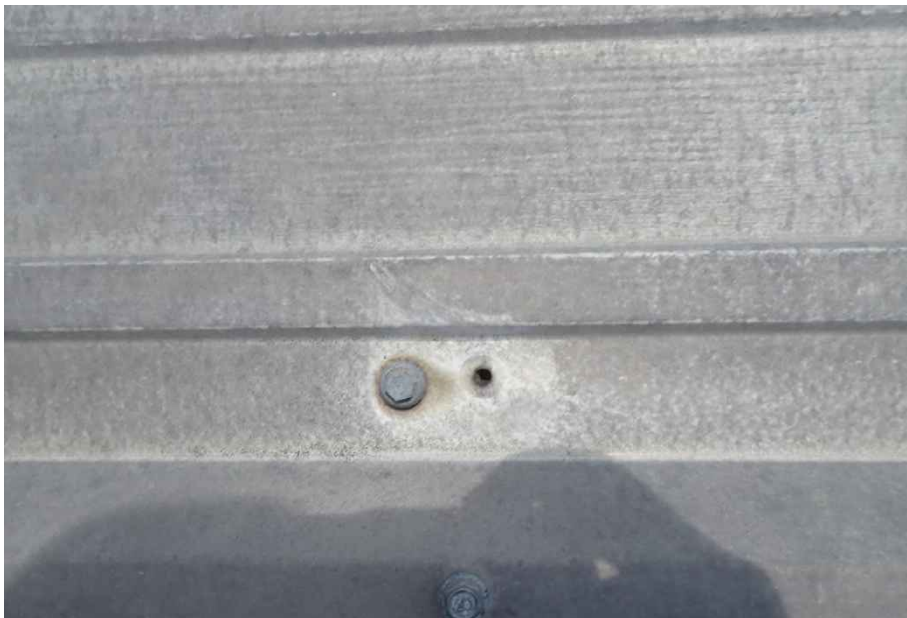
Photograph 18.

View of a missing fastener.

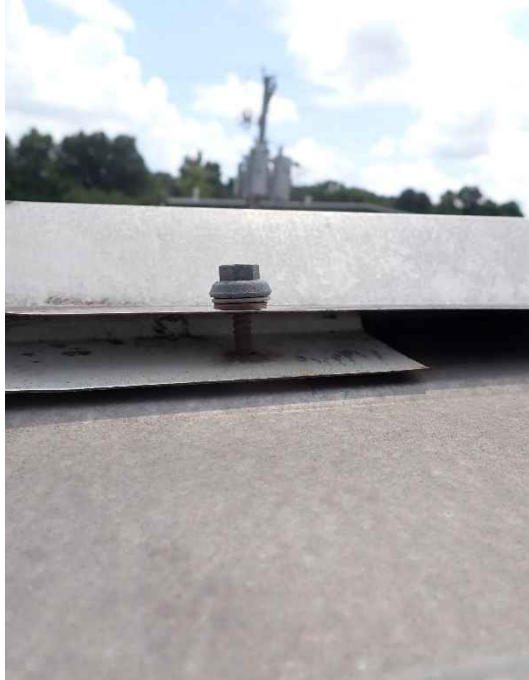
Photograph 19.

View of withdrawn fastener.

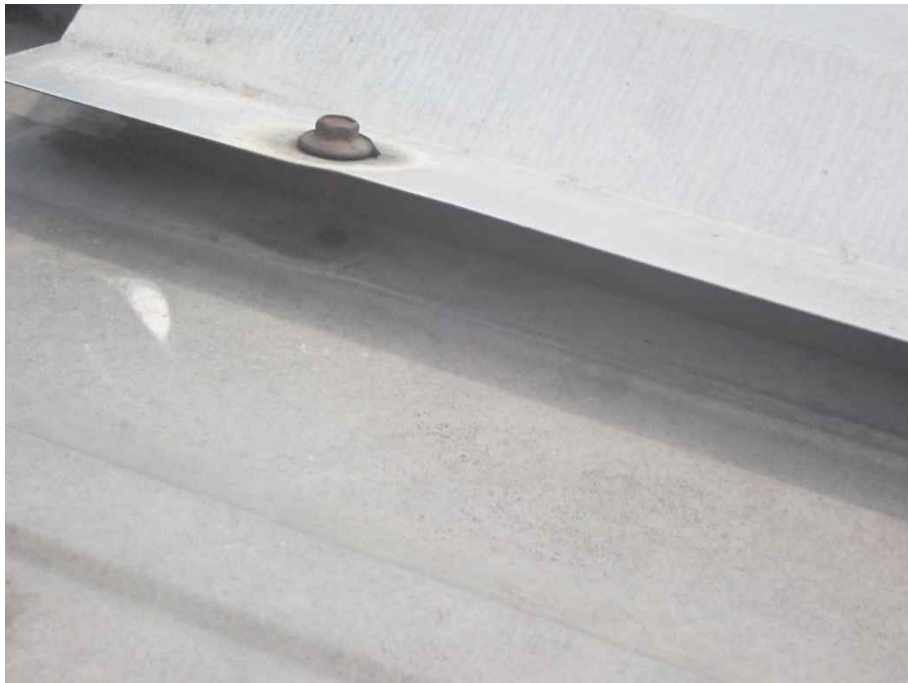
Photograph 20.

View of withdrawn fastener.
